# Smoke and Dye Testing Summary

## High Level Sewershed

Run Summary							
Test ID	Test Type	Date Inspected	Company / Super.	Nearest MH	Ground Condition	Notification Made?	
D1028-167	Dye	4/27/2009	ADS/TM	S11GG_030MH	Dry	NA	
Address	3001 Presbury Street		Location	Curb	Status	Public	Source Catch Basin

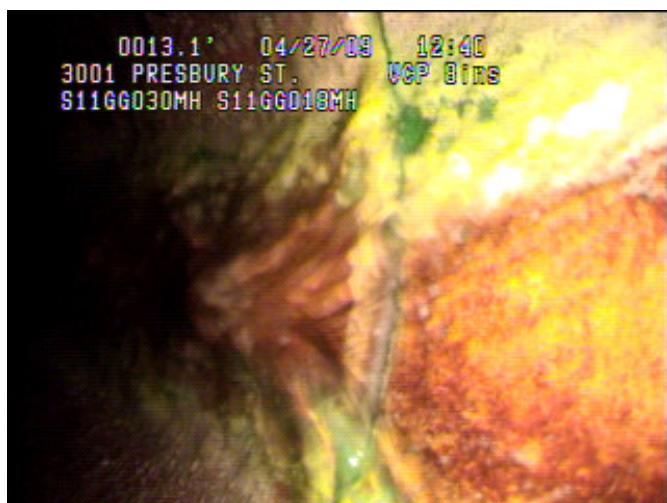
**Picture** \D1028-167-OB01-P01.jpg

**Comments** Dye observed 13.1 ft. downstream of S11GG\_030MH. Infiltration runner at joint from 5 to 7 oclock.

**Comments** 13.1 ft. downstream of S11GG\_030MH along S11GG\_030G1.

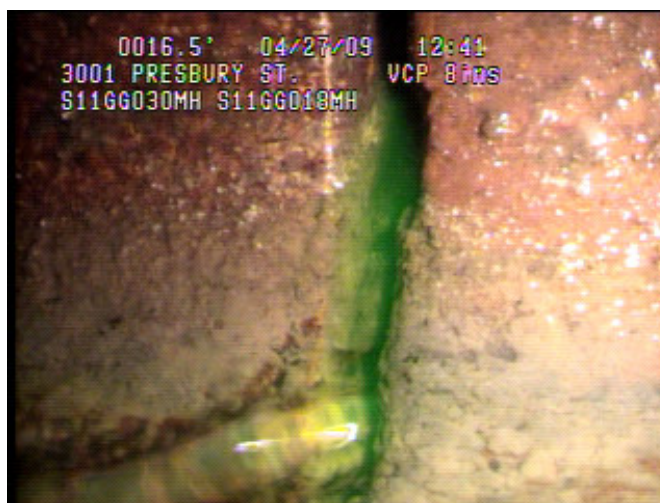
**Picture** \D1028-167-OB02-P01.jpg

**Comments** Dye observed 16.5 ft. downstream of S11GG\_030MH. Infiltration runner at joint at 5 oclock.

**Comments** 16.5 ft. downstream of S11GG\_030MH along S11GG\_030G1.

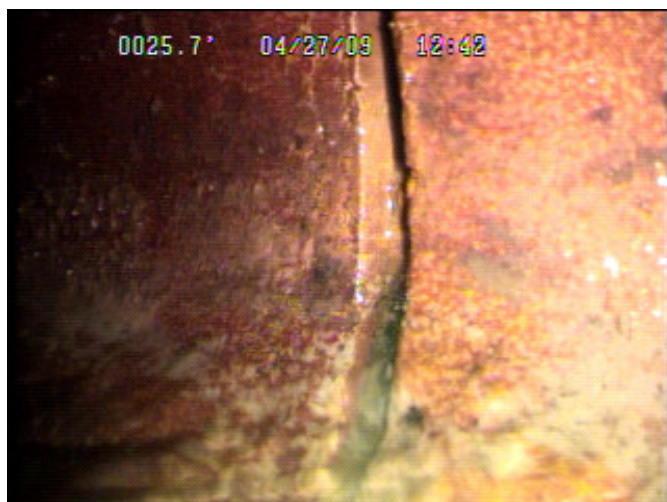
**Picture** \D1028-167-OB03-P01.jpg

**Comments** Dye observed 25.7 ft. downstream of S11GG\_030MH. Infiltration runner at joint at 5 o'clock.

**Comments** 25.7 ft. downstream of S11GG\_030MH along S11GG\_030G1.
